平成 23 年度成果報告書

「カンボジア王国における高性能鉄吸着剤を用いたヒ素汚染地下水の浄化
技術の研究開発」

独立行政法人新エネルギー・産業技術総合開発機構

(委託先) 国立大学法人高知大学

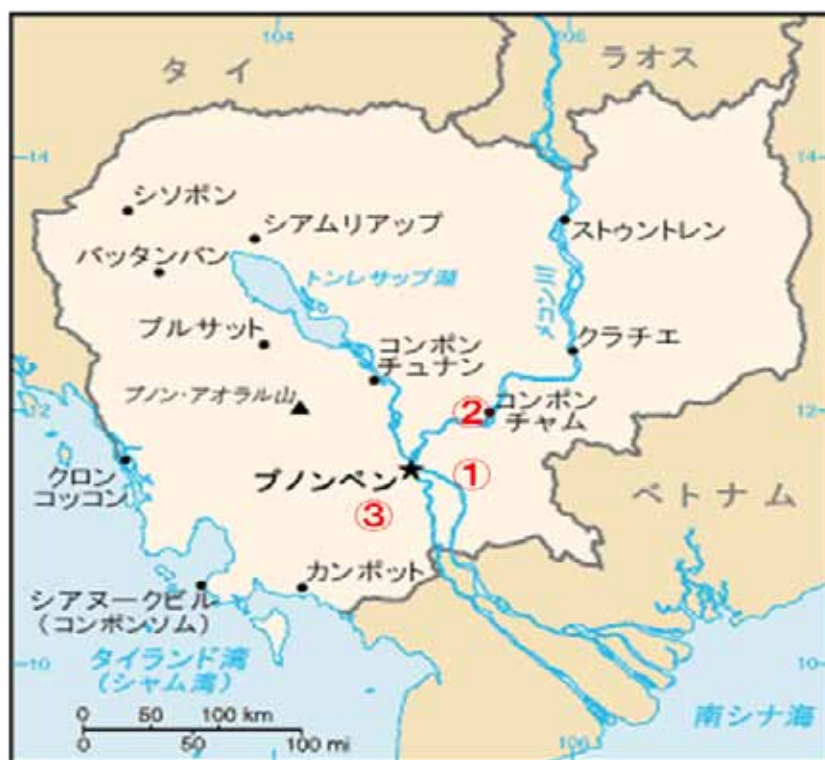
図 3 現地調査及び浄水装置設置した州
(カンダール、コンボンチャム、プレイベン)

カンダール、プレイベン及びコンボンチャム州に設置した 16 基のヒ素除去浄水装置を稼働させ、ヒ素除去の実証試験を行った(図 3)。2011 年 5 月から 2012 年 2 月まで毎月一度処理水を採取し、水質をモニタリングした。

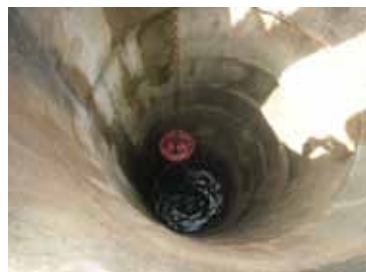
掘り井戸

写真は現地で確認された井戸のタイプを示している。河川に近いところでは河川水を利用しているが、河川から離れているところでは掘り井戸、手押しポンプ井戸、電気が通っている場所では電気ポンプ井戸が使われている。

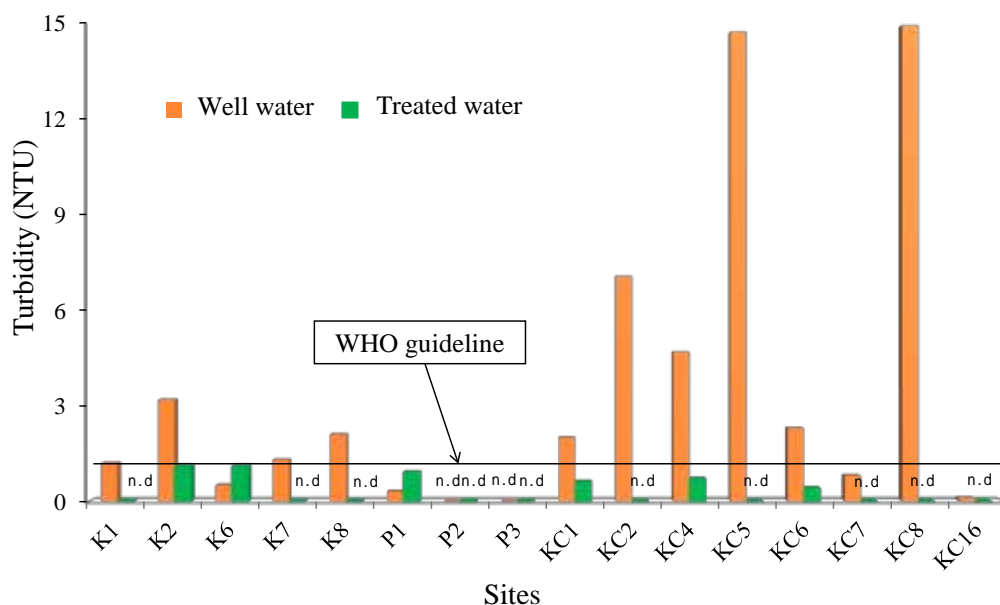
図8 井戸原水と処理水の濁度

図 8 は井戸原水と処理水の濁度を示している。原水の場合、16 点中 9 点が WHO の基準値を超えていたが、浄水装置を通すことで、ほとんどの井戸で濁度を基準値以下に下げることができた。K2 と K6 は 1.1NTU を示し、基準値の 1NTU をわずかに上回った。

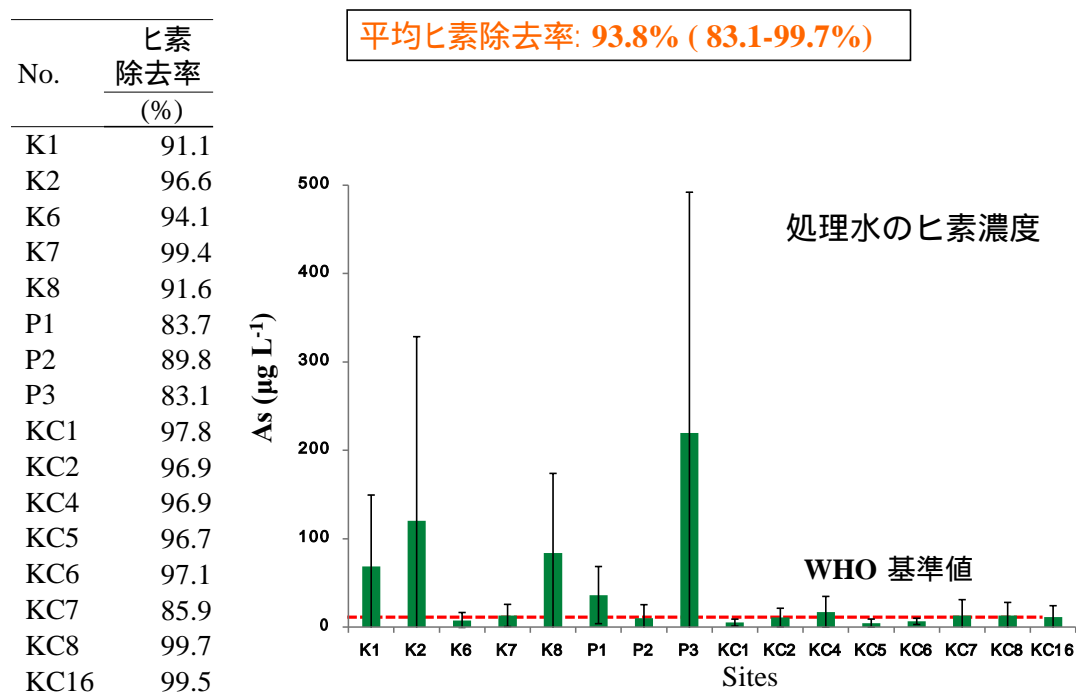
図9 ヒ素除去率と処理水のヒ素濃度

10 ヶ月のヒ素濃度の平均値をみると、4 点が $0 \sim 10 \mu\text{g L}^{-1}$ 、8 点が $10 \sim 50 \mu\text{g L}^{-1}$ 、4 点が $>50 \mu\text{g L}^{-1}$ を示した(表 9 と図 9)。

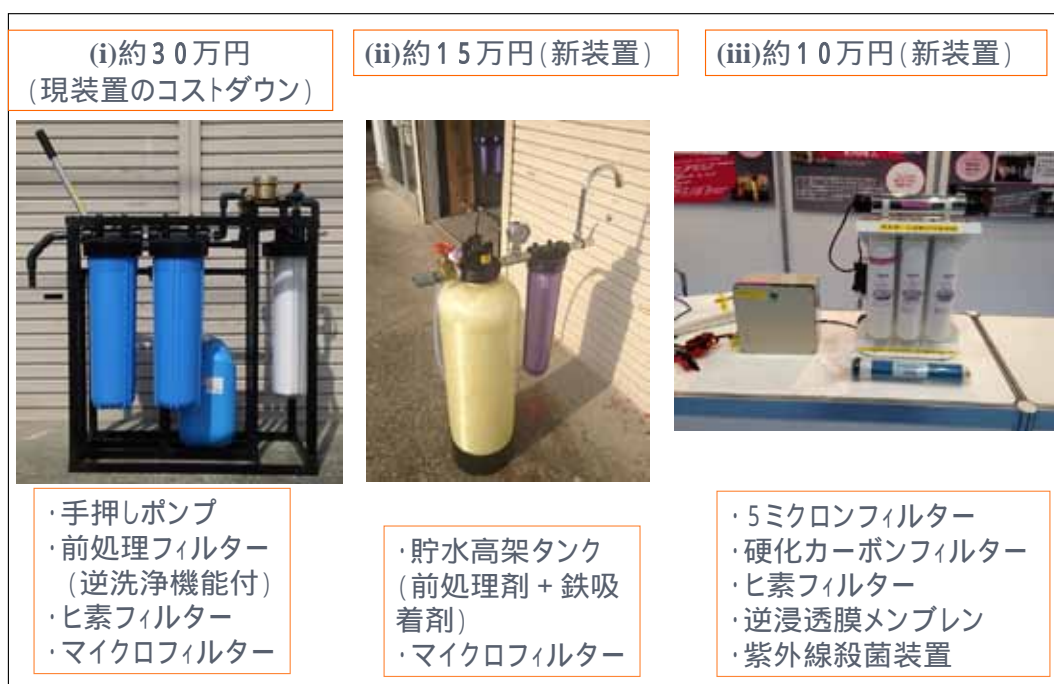
約 500g の鉄吸着剤を入れた小型装置で、紫外線殺菌装置をつけて水の消毒を行う。病院、保健管理センター、患者の自宅などで使用可能です。コストは 10 万円程度である。

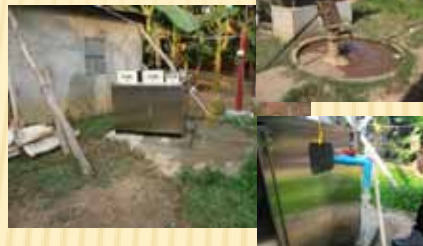
図1 装置外観と現地での設置の様子

表 4 が示すように、井戸原水の濁度は 10 井戸で WHO の基準値を、ヒ素濃度は 16 井戸全部で WHO の基準値を超えている。浄水装置 16 基の内、8 基は電動かつ逆浸透膜 (RO) 付きで、8 基は手動で RO なしとなっている(図 5 と図 6)。ヒ素フィルターには鉄吸着剤 2kg、ヤシ殻活性炭 4kg、大砂 500g および小砂 500g が層状に充填されている(図 7)。なお、鉄吸着剤は非晶質で粒径が約 3mm、ヤシ殻活性炭は多孔質で粒径が 500 μm 、また大砂は多孔質で粒径が 5-8mm、小砂は多孔質で粒径が 1mm のものを使用した。

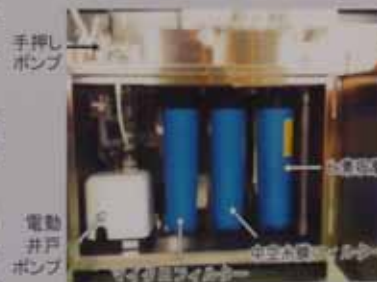
バックフイムロー 逆浸透膜メンブレン

手押しポンプ 電動井戸ポンプ フィルター

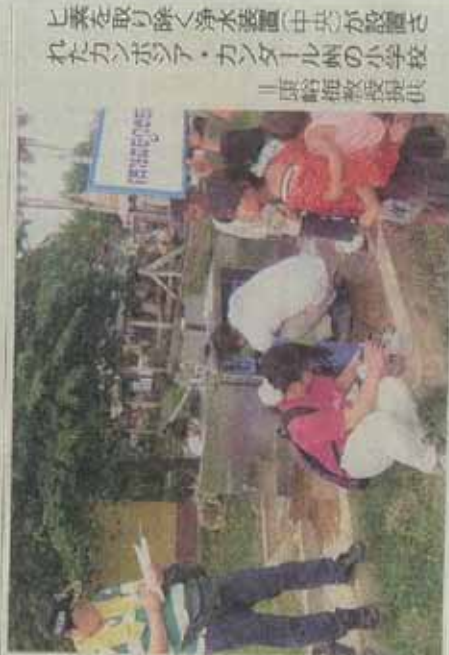
康船穂教授提供

は基準値の約6倍の903ppmのヒ素が検出された井戸もあった。研究グループは今年2、3月、完成した浄水装置(価約8万円、奥行き約80cm、高さ約1m)を公共性の高い学校や寺院などの16カ所の井戸に順次設置。その後の追跡調査で前見検査ながら、設置前に2372ppmを検出した学校の井戸など、多くの井戸が基準値内に収まり、現地の借民からも喜ぶの声が上がっているという。
